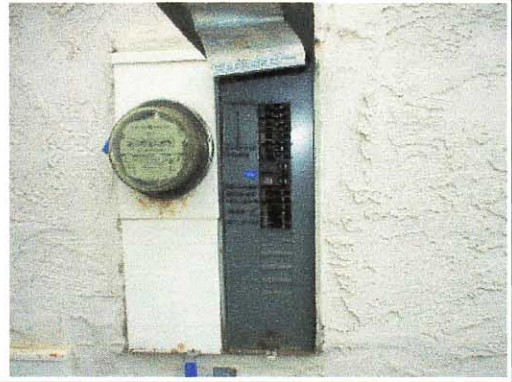
802 MAIN PANEL:

Located at the left side of the building.
