ROOF COVERINGS

ROOF INFORMATION

ROOF CONDITIONS

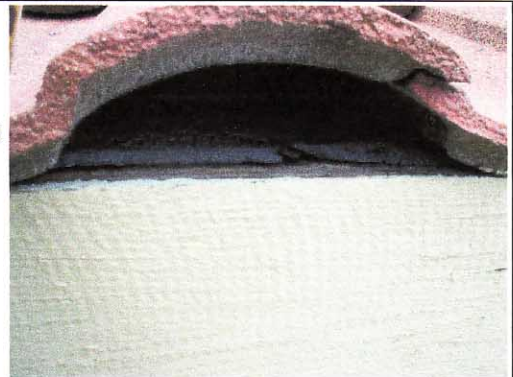
410 CONCRETE TILE:

[FE] There were a few unsecured, displaced or improperly fastened tiles. The underlayment felt was exposed to the weather. These conditions are conducive to roof leaks. We recommend further evaluation and corrections by a specialist in the appropriate trade.

[FE] The roof installation was substandard (no anti-ponding/ underlayment short at the roof's edge and ridge boards exposed). We recommend further evaluation and corrections by a specialist in the appropriate trade.
