## GARAGE/CARPORT CONDITIONS

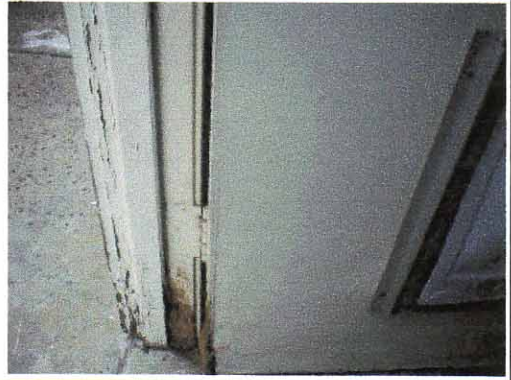
**1511 EXT DOORS:**

[CR] The door(s) were damaged/deteriorated. We recommend correcting the condition(s) noted.

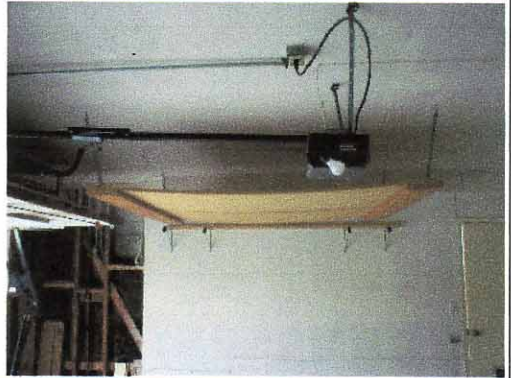
**1514 INTERIOR WALLS:**

a. [SC] There were homeowner-built shelves hanging from the ceiling/walls. The additional weight can damage the framing. We recommend it be engineered or removed.
