ROOF COVERINGS

ROOF INFORMATION

ROOF CONDITIONS

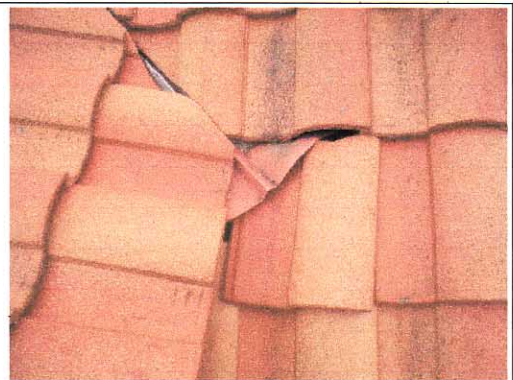
[FE] There were a few unsecured, displaced or improperly fastened tiles. The underlayment felt was exposed to the weather. These conditions are conducive to roof leaks. We recommend further evaluation and corrections by a specialist in the appropriate trade.

[FE] The roof installation was substandard (no anti-ponding/ underlayment short at the roof's edge and ridge boards exposed). We recommend further evaluation and corrections by a specialist in the appropriate trade.
